# Storm Damage Report

**Tri Investments**  
301 Flecha Ln,  
Laredo, TX 78405

### FIELD REPORT FOR INITIAL STORM DAMAGE INVESTIGATION

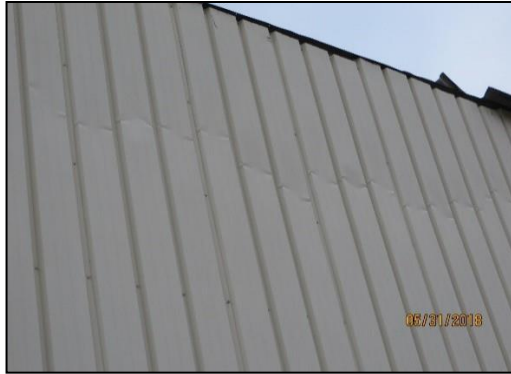
Crimped metal paneling

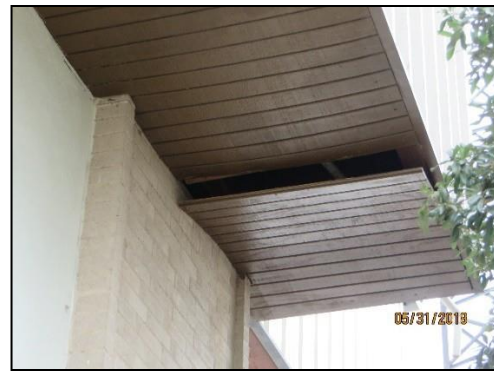
Wind damaged wooden soffit

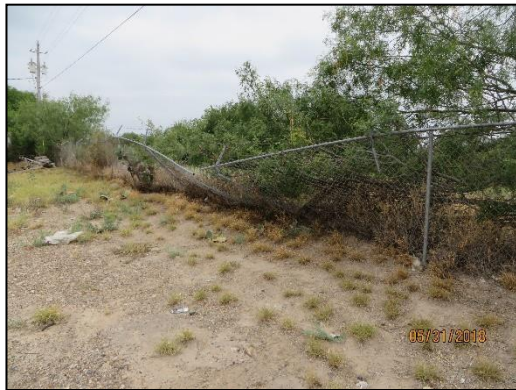
Damaged fencing from tree

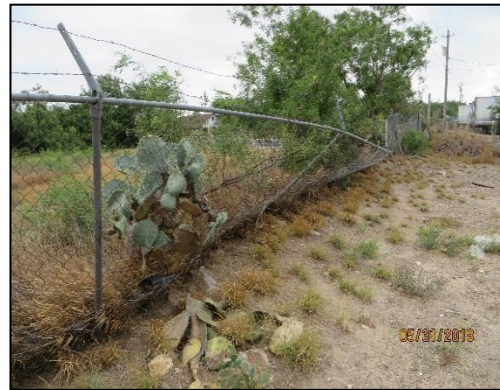
Damaged fencing from tree

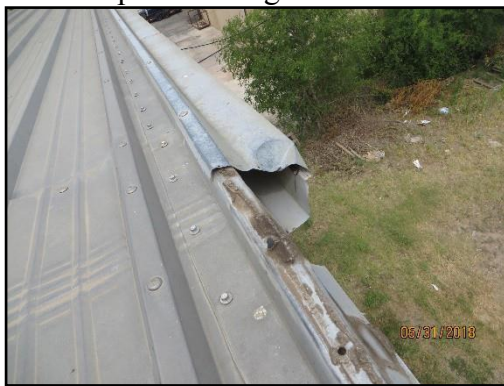
Damaged roof edge flashing

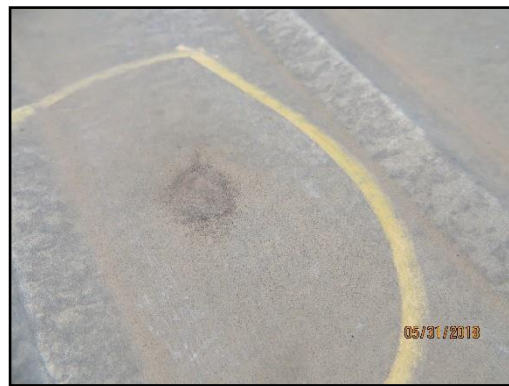
Impact damage

Damage to the metal roof panels from hail was caused by creating indentations that collect pollutants, sediment and water, causing premature corrosion to occur at the impact locations. Damage caused by wind included metal crimping. Removal of the damaged metal panels will be required. Based on similar projects and the age and condition of the panels, surgical repairs to individual panels will likely damage surrounding panels. Therefore, we are recommending complete replacement of the metal roof and metal wall systems.

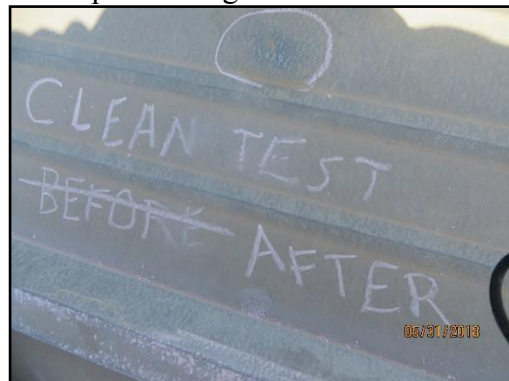
Clean test #1 after

- In a majority of these impacts, dirt and debris could be observed within the impact mark consistent with restricted drainage of water.
- Two clean tests were performed on separate impact damaged areas. Once the dirt and debris were removed from the impact damaged area, deformation and premature coating failure of the metal roofing was readily observable.
- A sample square was performed on the metal roof, the results are as follows:
  - Sample Square #1
    - 10' x 10'
    - 12 impacts due to hail identified
- Crimping was observed throughout the roof consistent with wind damage.
- Torn flashing was observed on the left elevation rake.
- Oil canning
- Uplift canning at Fasteners

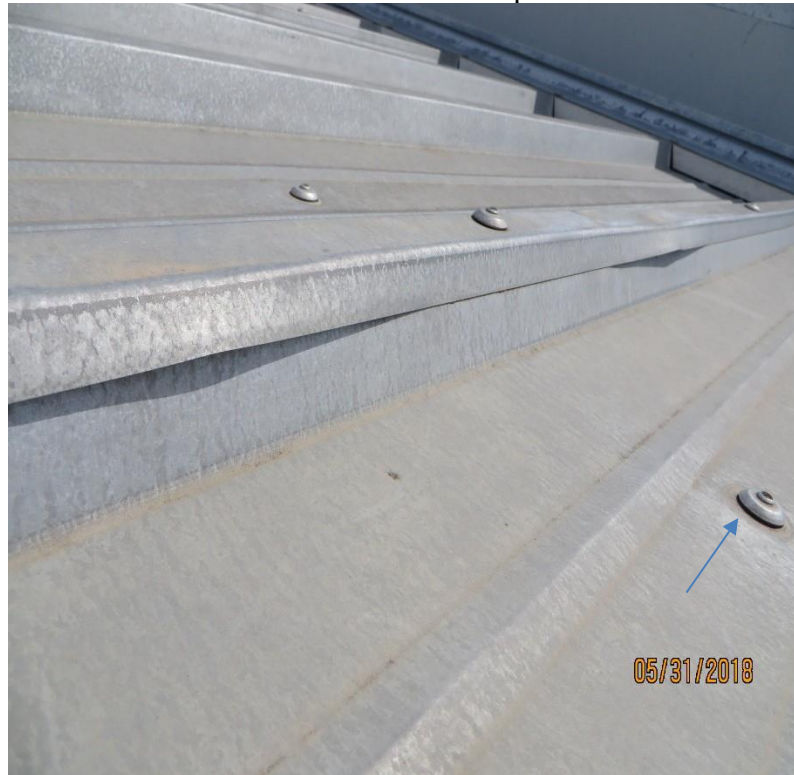
Oil canning at fastener and bent overlaps

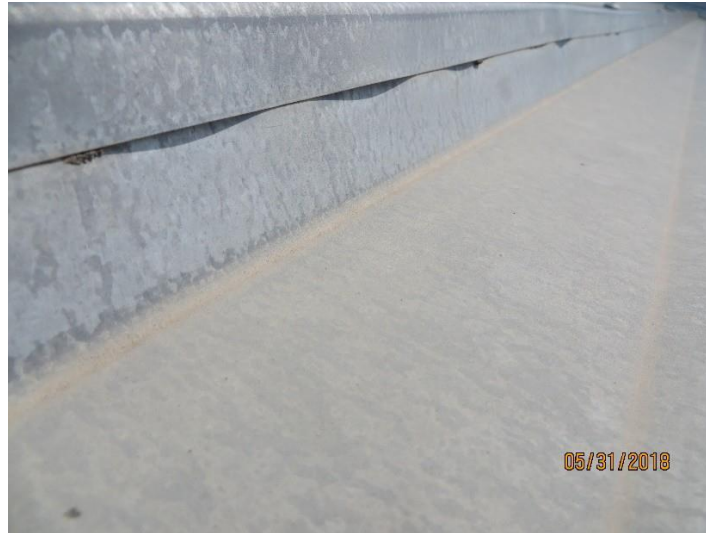
Typical storm created openings

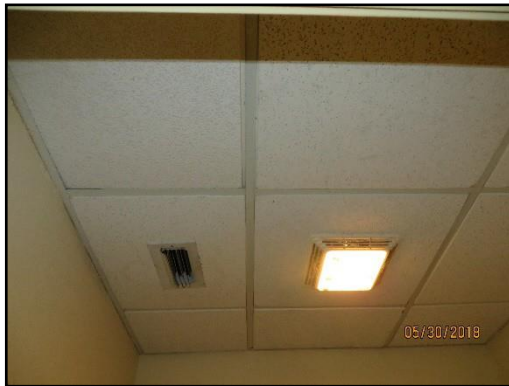
Water damaged ceiling tile

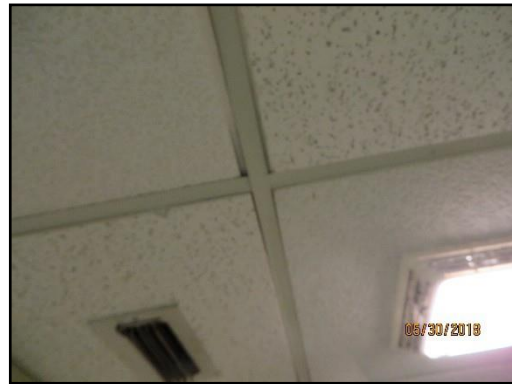
Water damaged ceiling tile

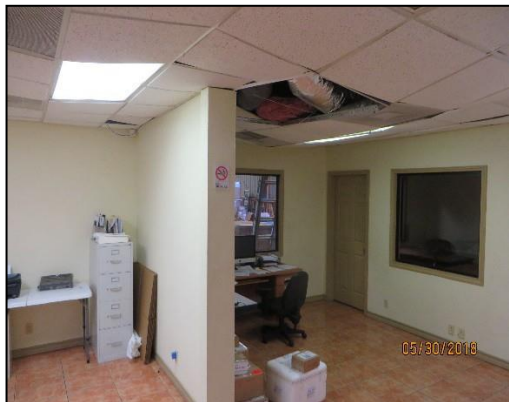
Wind damaged ceiling

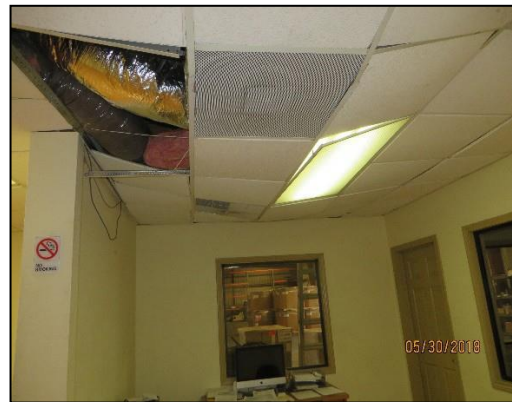
Wind damaged ceiling
